Glass Half Full Beam

Erika Lee, Grace Keflemariam, Amy Li, Tyler Palmer, Jackson Scharf, Seth Meyers, Rowan Preedy
Dept. of Materials Science & Engineering, University of Washington

PROBLEM STATEMENT

Design a box beam using dry fiberglass materials that will hold a distributive load of 5,600 lbf applied at the center.

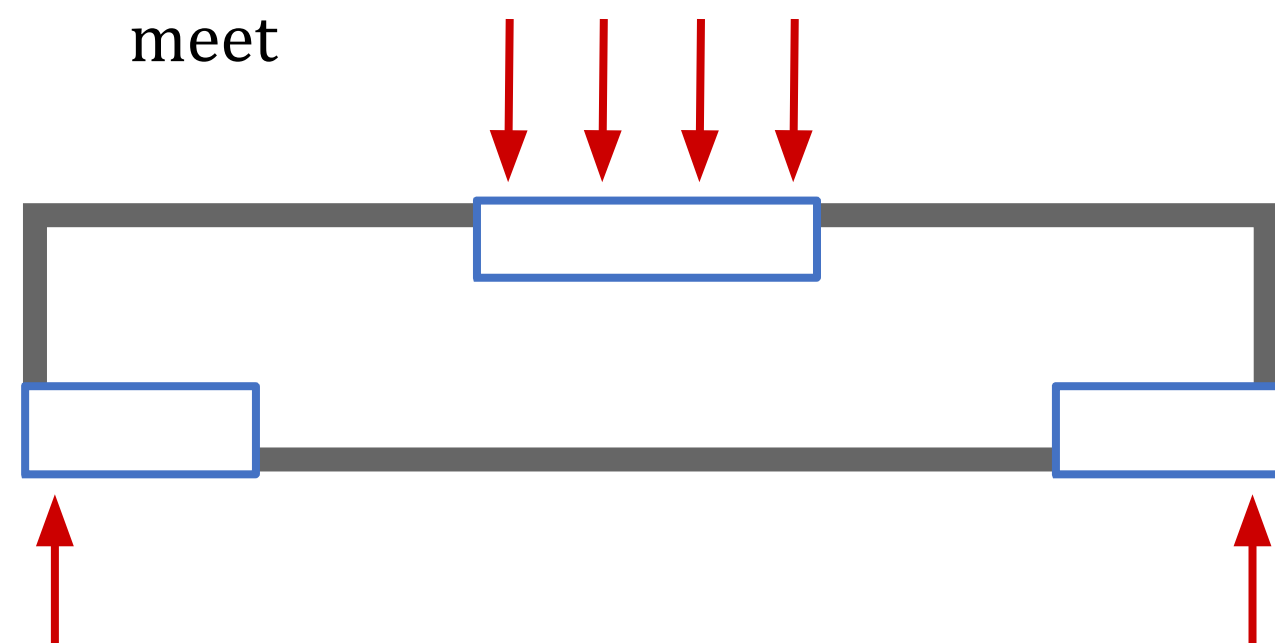
Figure 1: Reinforced sections (in blue) along the length of the beam with arrows showing force (in red).

There are four components to this beam:

- 6" diameter $\pm 45^\circ$ biaxial S-glass tube sleeves
- Satin 0° S-glass tabs at the 3 contact points
- Stitched $\pm 45^\circ$ biaxial E-glass for webs and tab reinforcements
- E-glass roving used as noodles to fill in gaps where web and top/bottom meet

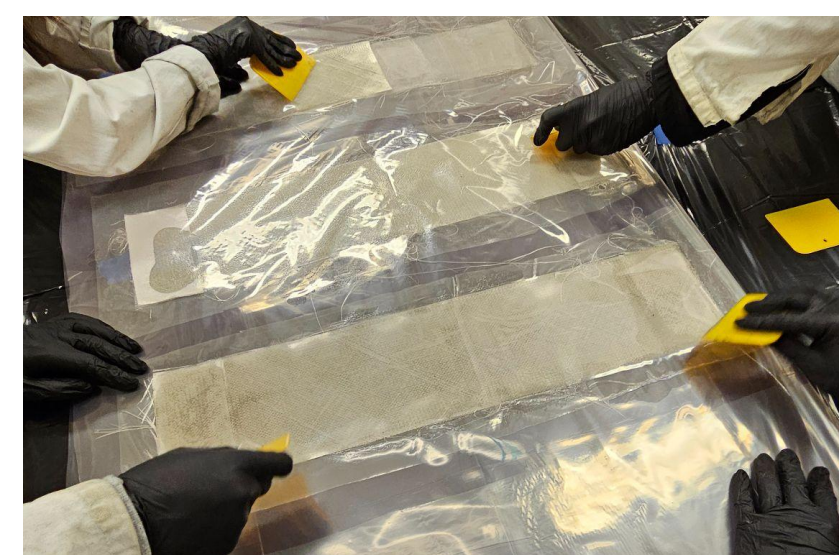
Figure 2: Spreading resin through plies.

Plies were cut on a CNC fabric cutting table. Then, they were layed up on release film by spreading resin (Pro-Set INF-114 and INF-213) through each ply before stacking another ply (Figure 2).

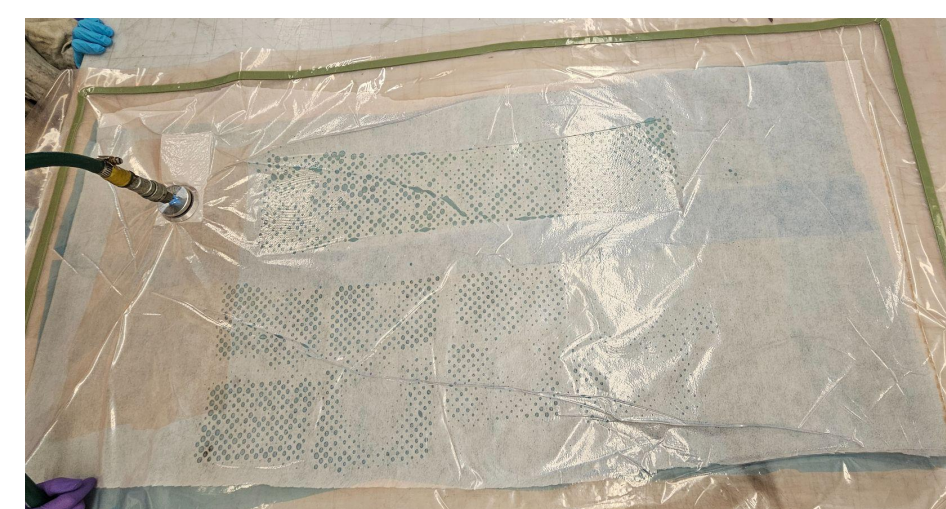
Figure 3: Debulking stacked plies.

Each stack was then debulked to remove excess resin (Figure 3). This is a new process implemented for better resin distribution and based on high resin content of previous beams.

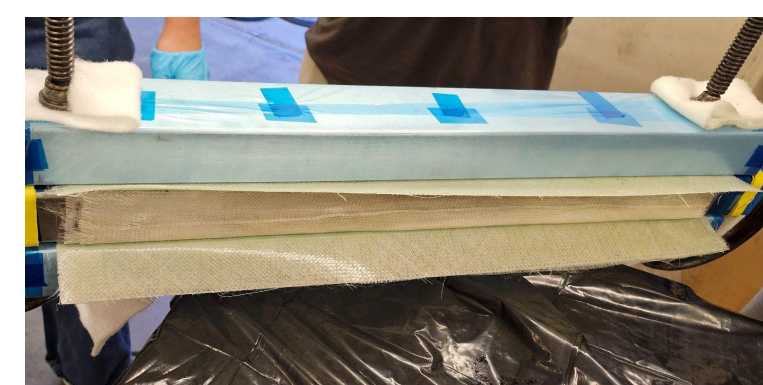
Figure 4: Beginning of assembly process.

The top, bottom, and webs are then assembled with noodles packed in the joinings (Figure 4), bagged, vacuumed, and finally placed in an autoclave under slight pressure to cure. After curing, the beam is removed, extracted with a mechanical extraction set-up, and trimmed with a wet-tile saw.

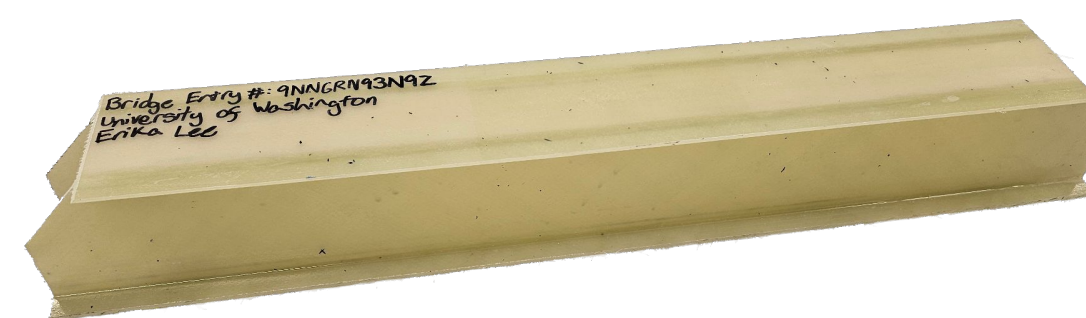
Figure 5: Final cured and trimmed beam.

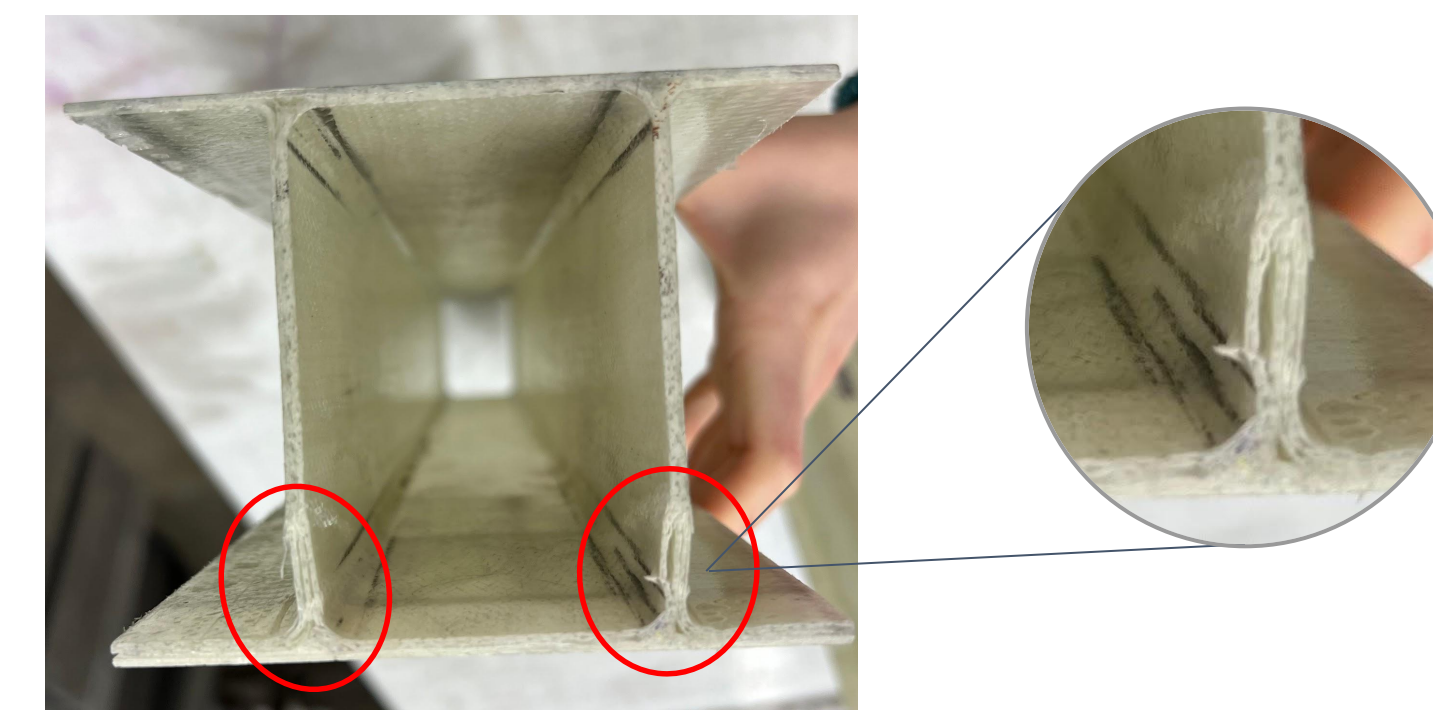
Figure 6: Beam failure points from cross-section view. Close-up view of delamination.

Previous beams failed under load at the bottom corners of the web and in crush at the top contact point (Figure 6). Plies were added to mitigate these issues.

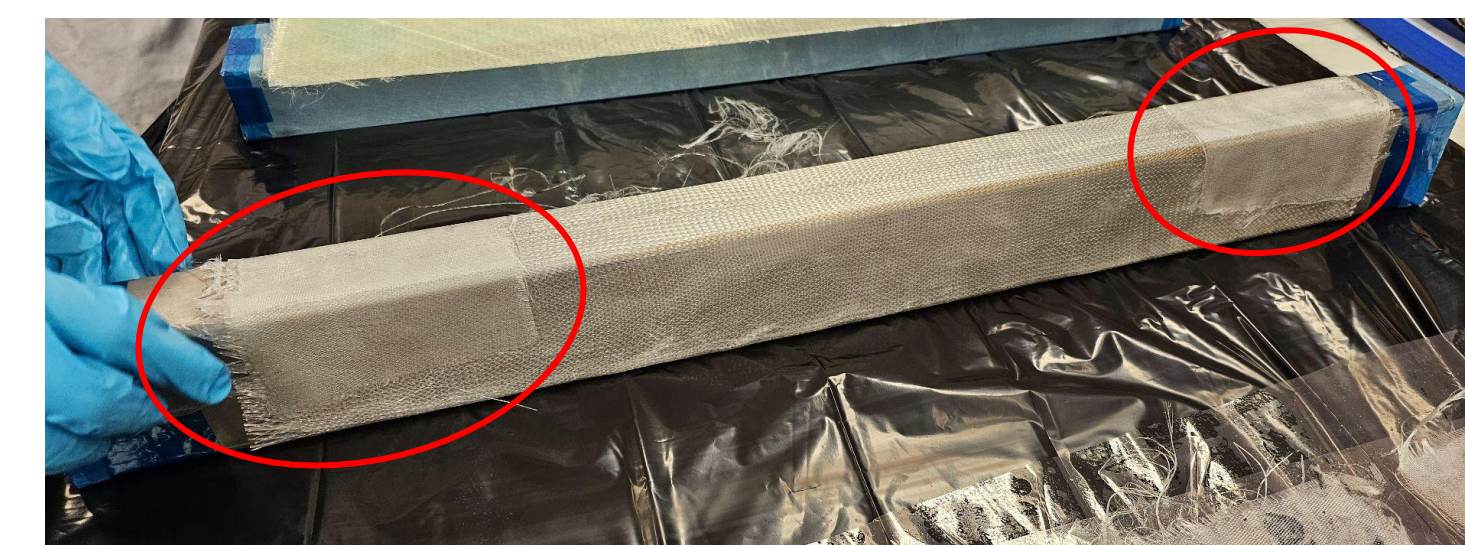
Figure 7: Tabs added to the center web part at the ends, encircling the tool.

By adding tabs around the ends of the center part and webs (Figure 7), the mode of failure was no longer along the corners joining the bottom and the web.

Adding additional tabbing to the top also helped prevent crush at the top contact load point.
